SUCCESS

In A High-Pressure Refinery Heat Exchanger Diaphragm Removal/Retrofit

Doug Hughes, Valero Refining / James Cesarini, Petro Spect / Erik Howard, Taper-Lok®

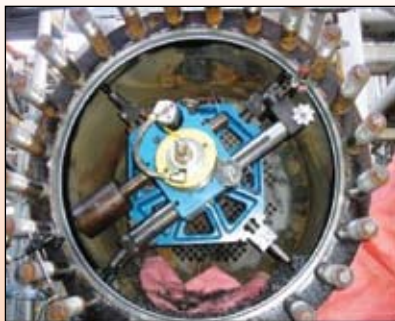
Fig. 4. Machining pressure seal female pocket with ID mounted tool

3. Field machine female pocket into exchanger channel (Fig. 4)

The Taper-Lok pressure-energized seal geometry requires two sealing surfaces. One a female pocket, the other a male nose. The female pocket was machine cut into the exchanger channel while the new, fabricated channel cover plate featured the male nose. During assembly, an additional benefit to the design was observed. This male nose on the channel cover plate configuration acted as a guide.

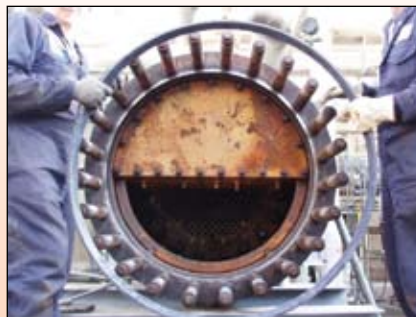
Fig. 5. Inserting pressure seal into female pocket

4. Insert pressure seal ring into pocket (Fig. 5)

Since the Taper-Lok geometry of the female seal pocket is angled, the seal ring was installed into the female pocket and held in place by friction, providing a hands free, safe installation of the channel cover plate.

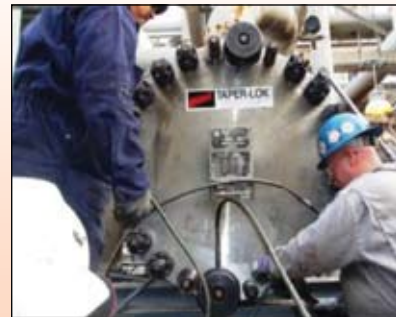
Fig. 6. Hydraulic tensioning and installation of mechanical tensioners

6. Pre-tension studs (Fig. 6)

To ensure that the channel cover plate was assembled square and free from misalignment and to reduce bolt interactions, hydraulic tensioning equipment was utilized. Four tensioners were used at 90 degrees and the tensioners were kept under load while all nuts were installed and hand tightened.

A second deviation from the exchanger's original design was applied at this time. In lieu of the traditional heavy hex nuts, mechanical multi-jack bolt tensioners were utilized. This also proved quite fruitful as torque wrenches were then used to apply the proper torque required to seat the pressure-energized seal ring. The traditional impact (and accompanying crane used to hold it in place) was rendered obsolete.
